Date: 21-Jul-2014

Inspection No. 12898-1327

Visual Property Inspection

**Sandy Bay Drive
Turtle Lake, Saskatchewan**

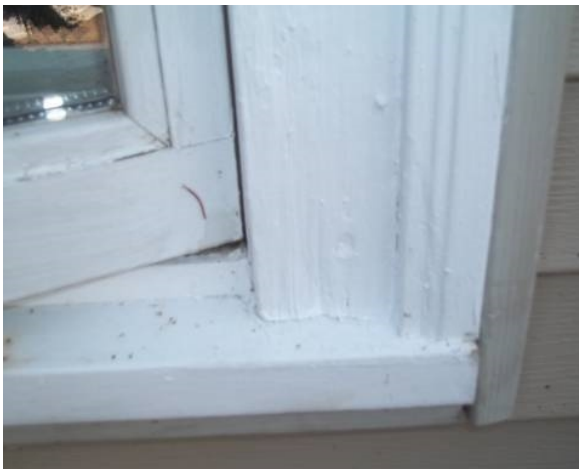
Fresh paint noted on windows through out home. Further evaluation required to determine extent of moisture related danger. Soft spot noted, possible rot.

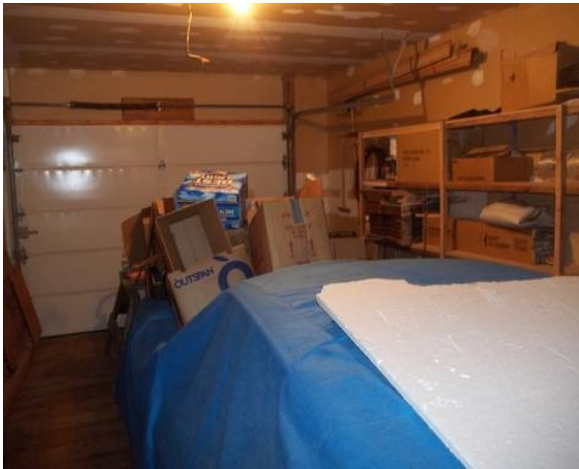
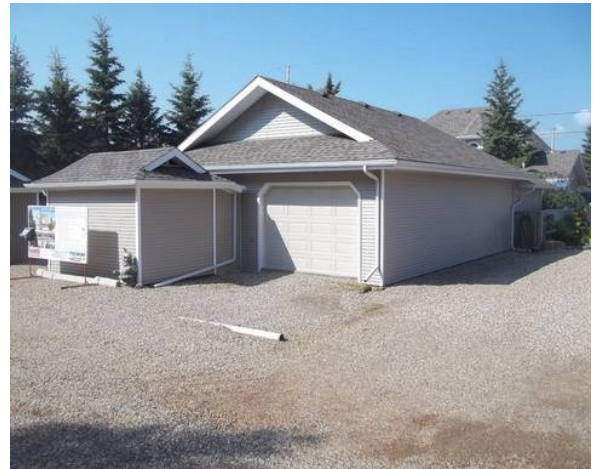
Limited inspection due to personal belonging being stored in garage at time of inspection.

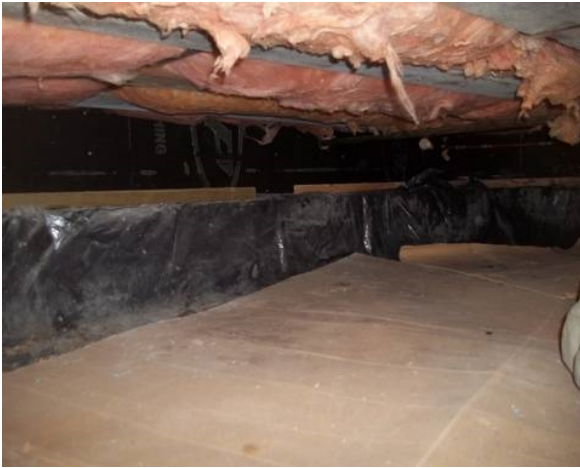
Heated area.

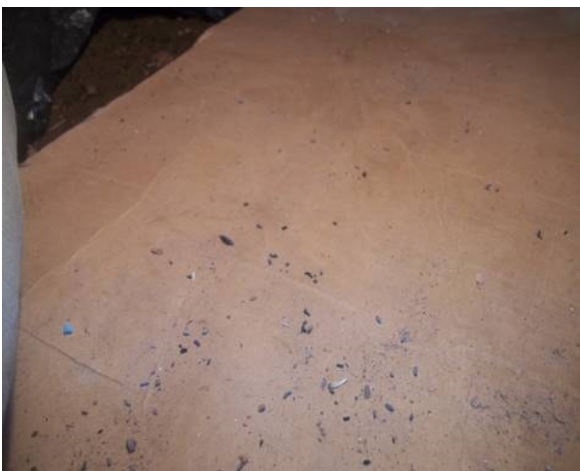
Rodent feces noted. Monitor for further presence in the future.

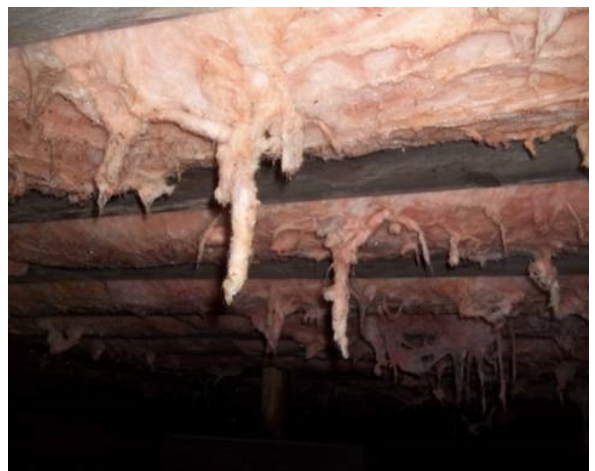
Condensation noted.

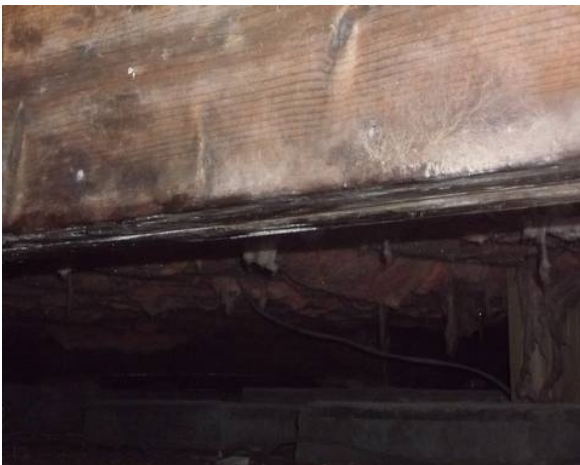
Staining noted ,

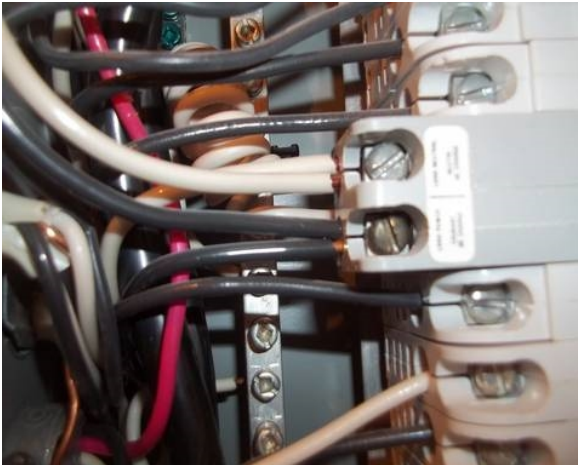
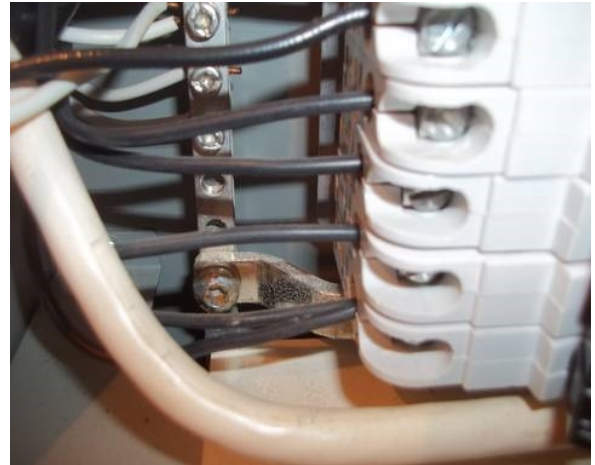
- Improper Aluminum Copper Copper Clad Other
 Non-Metallic Sheathed Armoured Cable Knob & Tub
 Double Tapping Spliced Corrosion Scorched

Consult qualified electrician to correct double tapped connections to reduce hazards associated with over fusing.

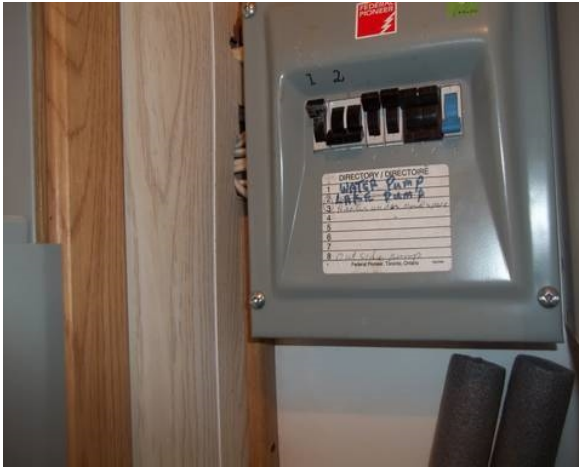
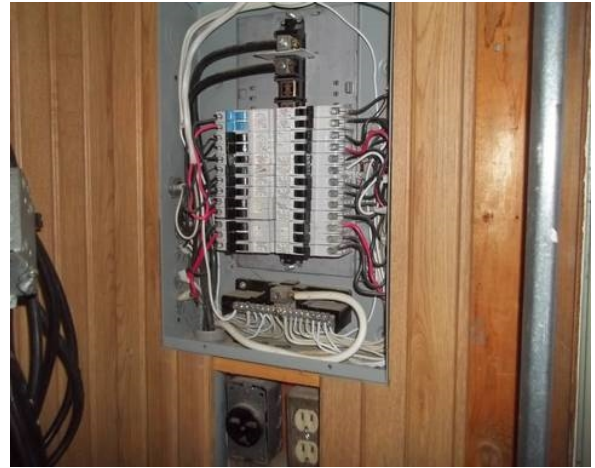
Garage Panel

Sub Panel Noted IN Garage. Contact electrician to further evaluate panel and correct all deficiencies. Double tapping noted.
