Visual Property Inspection

12 Riverbend Cr
North Battleford, Saskatchewan

Date: 21-Apr-2015

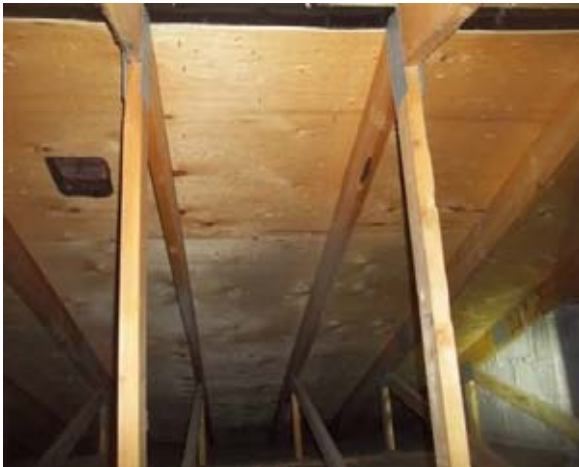
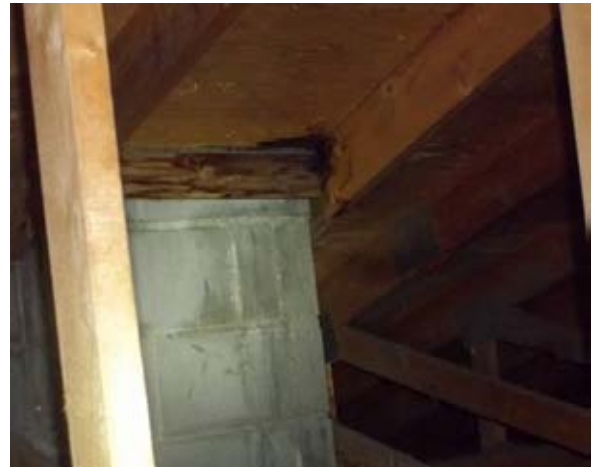
Stain noted. Dry at time of inspection.

Consult a qualified roofing contractor to determine cause of water entry and correct as required to reduce further damages.

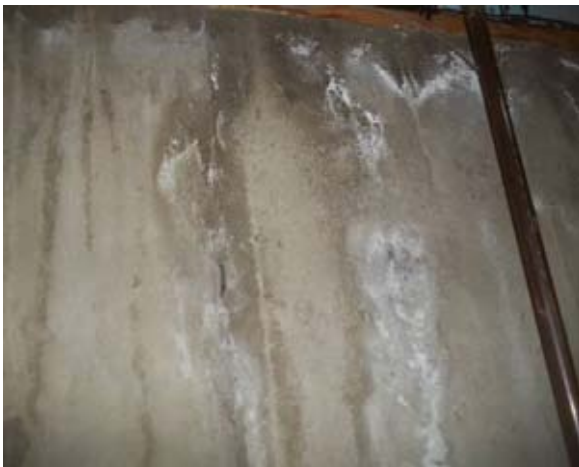
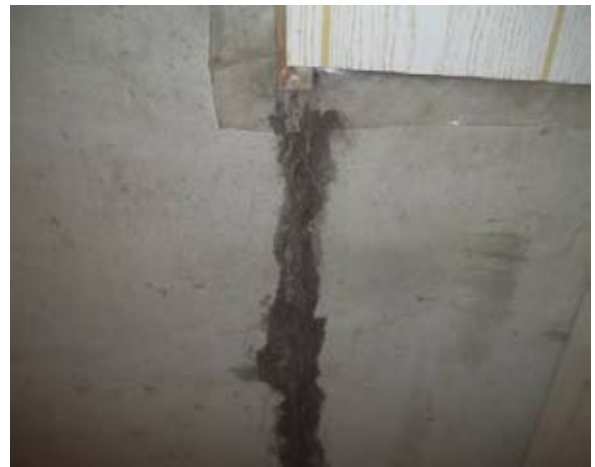
Crack / repair noted.

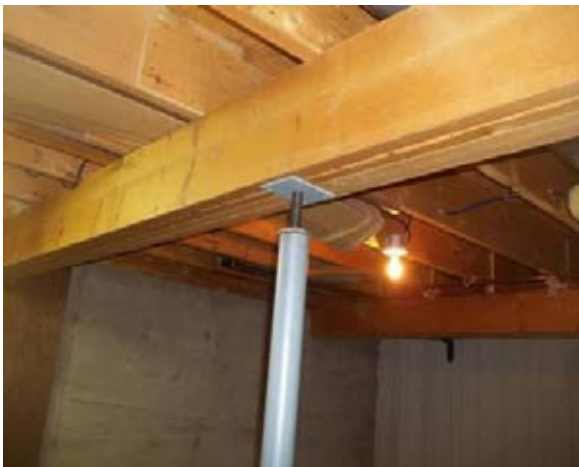
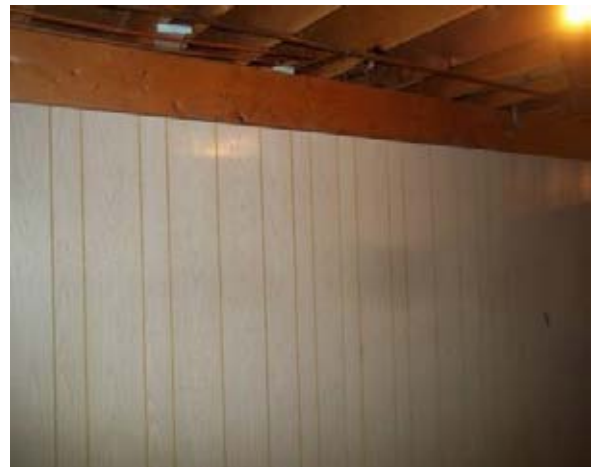
Three beams noted.

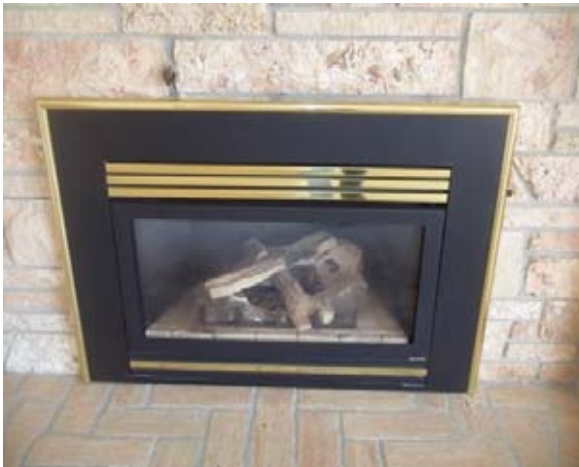
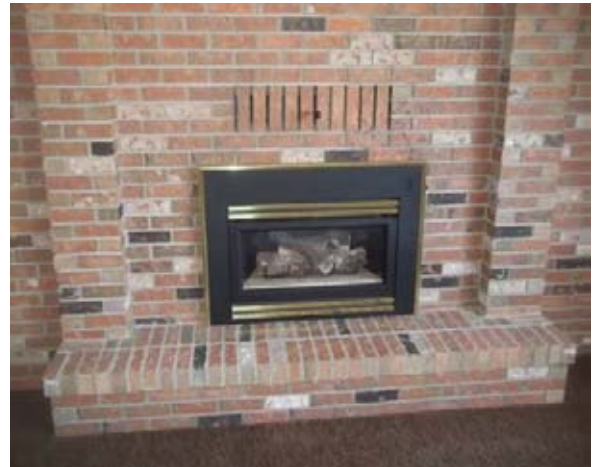
Fireplace Front

Some cracking noted .

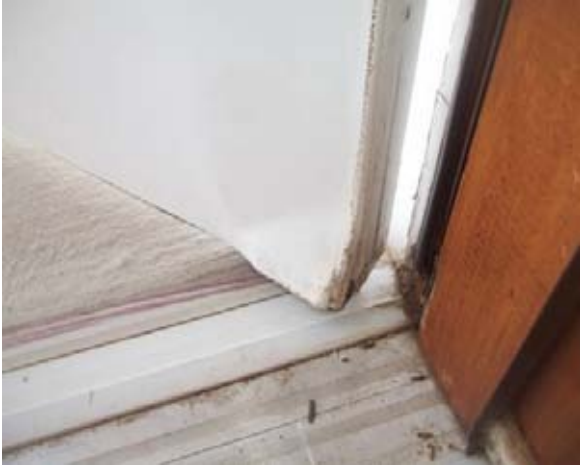
Back door

Damage noted to back patio door.
