**Visual Property Inspection**

1491 103rd  
North Battleford, SK

**Prepared for :**

Norman Diane Seltzer

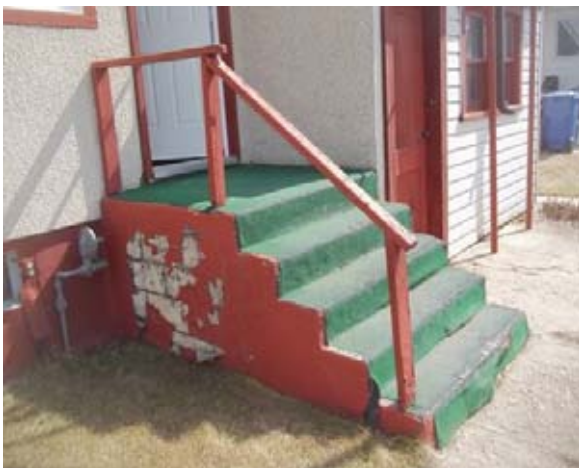
**Railing** **Damaged: Yes**

*Replace damaged hand rail to reduce associated hazards.*

Replace damaged hand rail to reduce associated hazards.

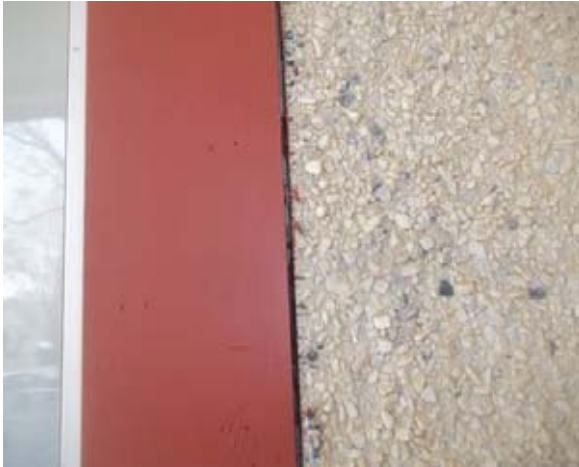
*Vinyl inserts noted through out the home Original wood Unites will require regular maintenance to reduce deterioration,*

Seal all gaps and cracks to reduce moisture related damages.

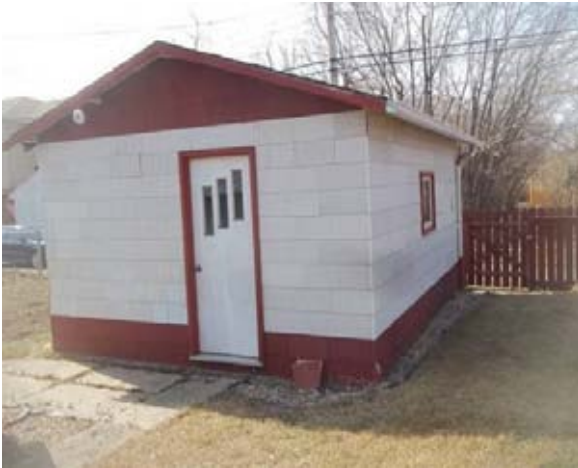
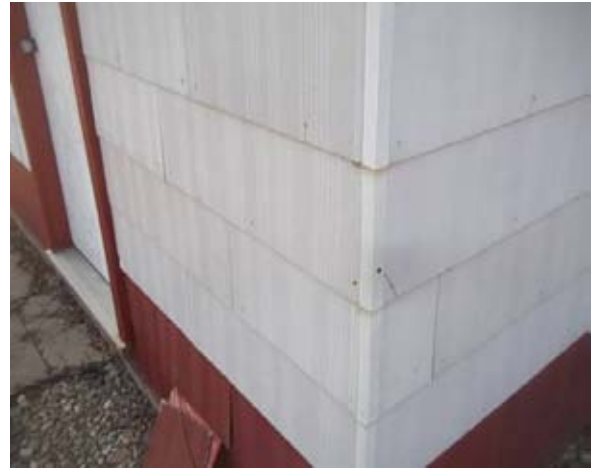
*Storage Shed only. Exempt from inspection due to no access. Suspect siding material noted. Recommend having tested. Budget to replace shingles.*

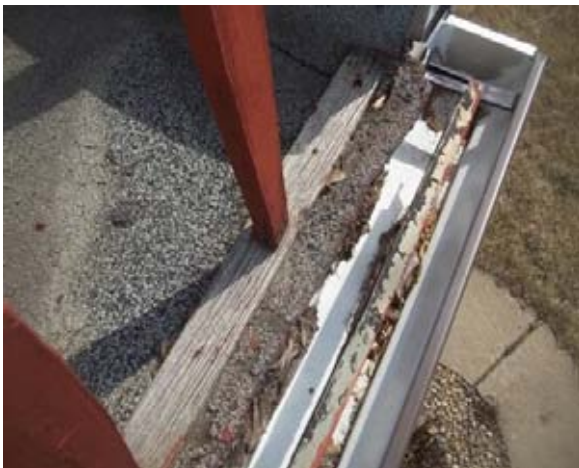
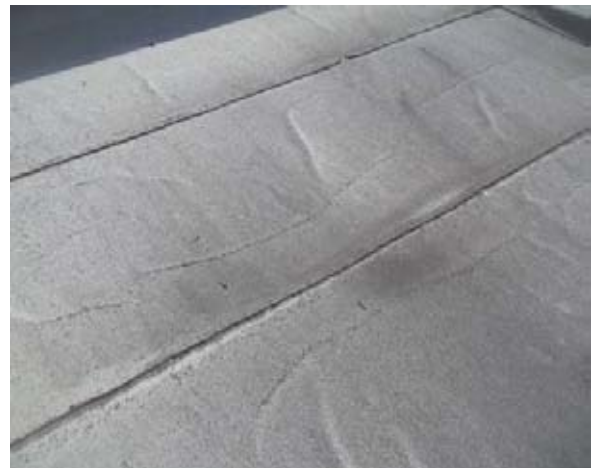
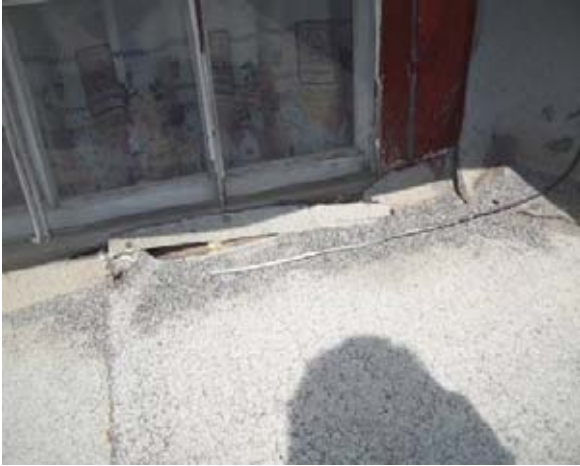
*Signs of deterioration noted. Recommend having further evaluated to determine extent of damages. Budget to replace/ repair to reduce further damages.*

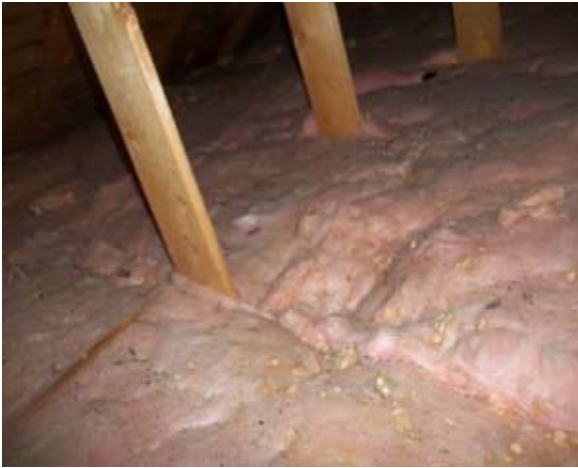
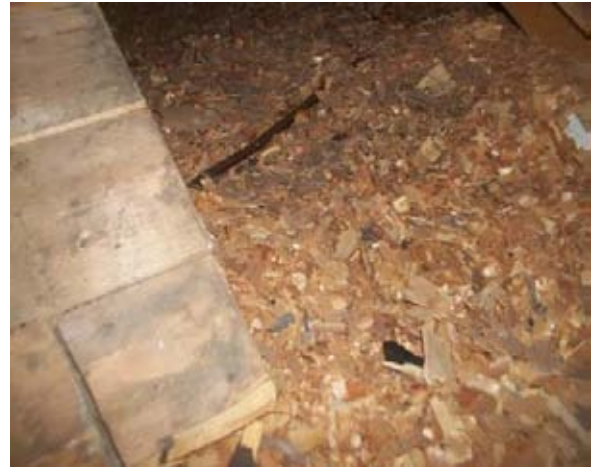
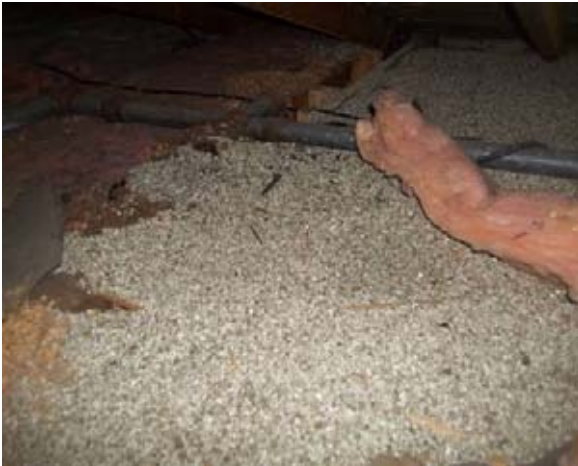
*Vermiculate insulation noted, possible asbestos present. Have tested. Read attached literature.*

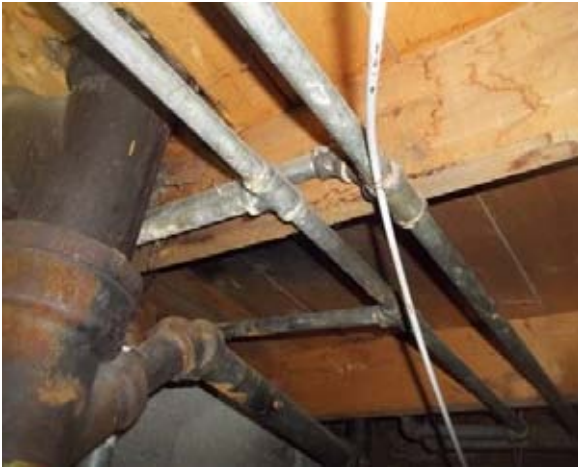
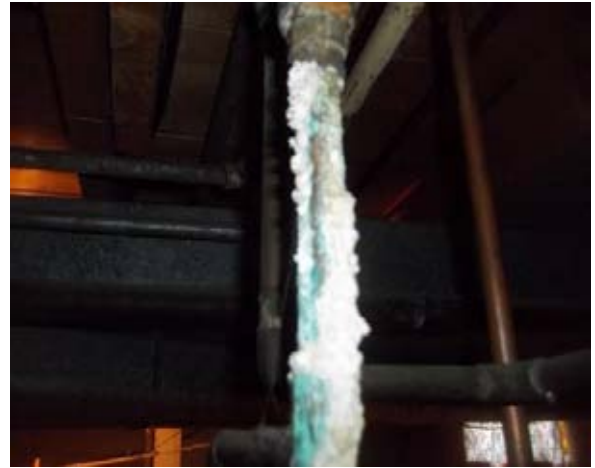
*Budget for system replacement. Galvanized plumbing is corrosive by nature. Monitor for decreased water flow indicating initial signs of failure. Contact plumber to repair leak as required to reduce moisture related damages.*

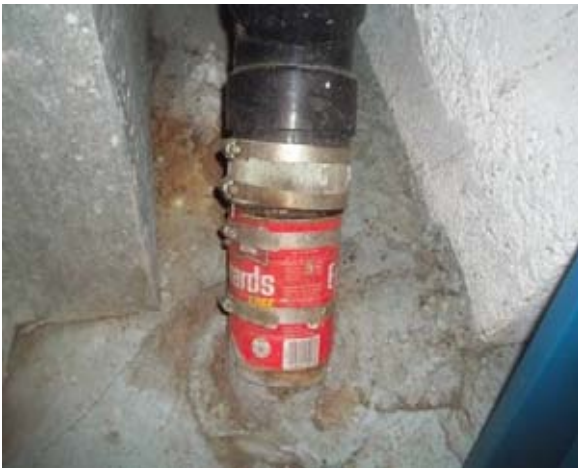
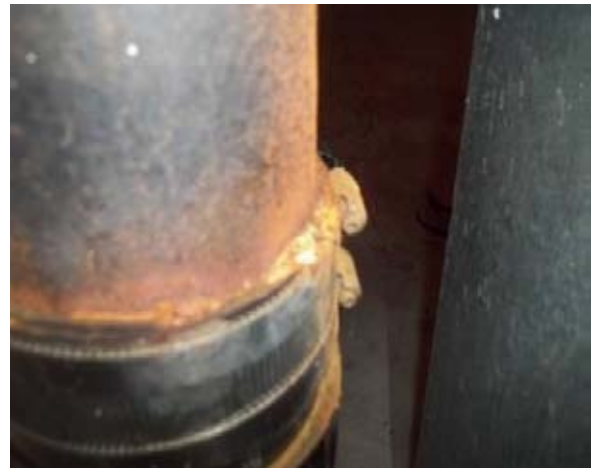
*Budget to repair and or replace drainage pipes. Corrosion and suspect repairs noted. No leaks at time of inspection.*

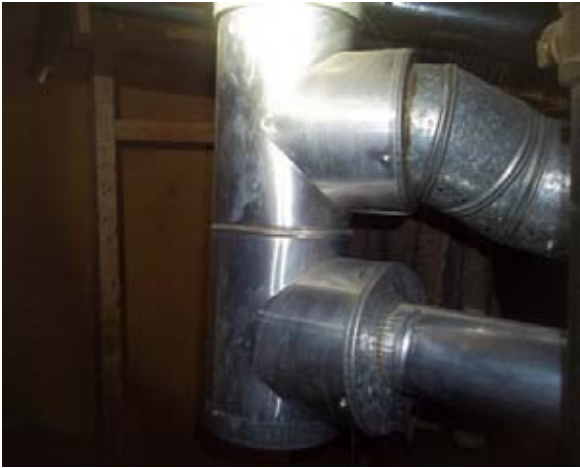
*Suspect venting noted. Contact expert to further evaluate and correct as required to reduce any associated hazards.*

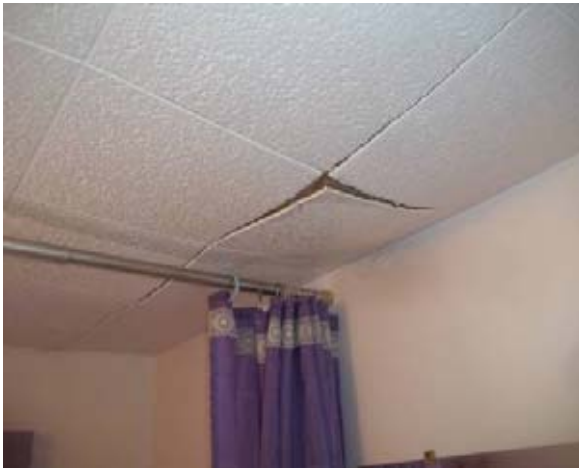
**Damaged: Yes**

*Further investigation required to determine cause of damages.*

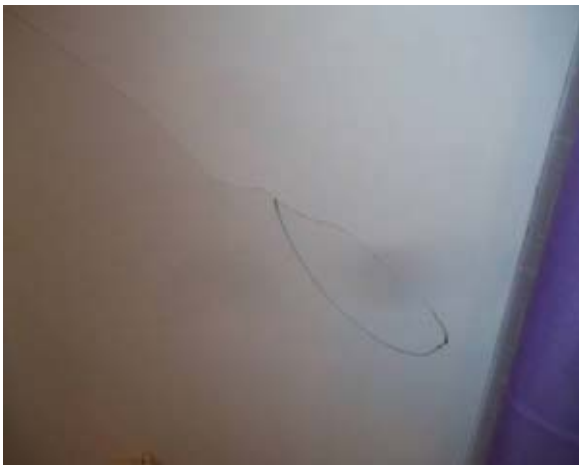
**Damaged: Yes**

*Budget to replace to reduce moisture related damages.*

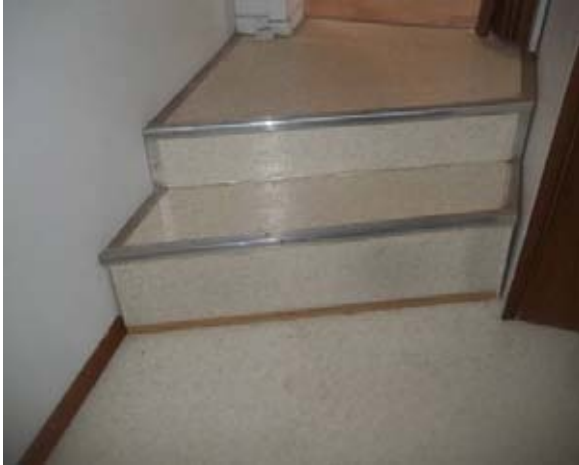
Possible trip and or safety hazard. Suspect stair rise height noted.
