Visual Property Inspection

2143 101 Str
North Battleford, SK

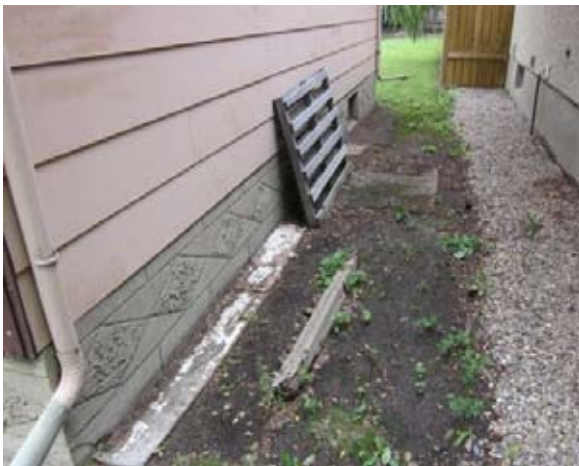
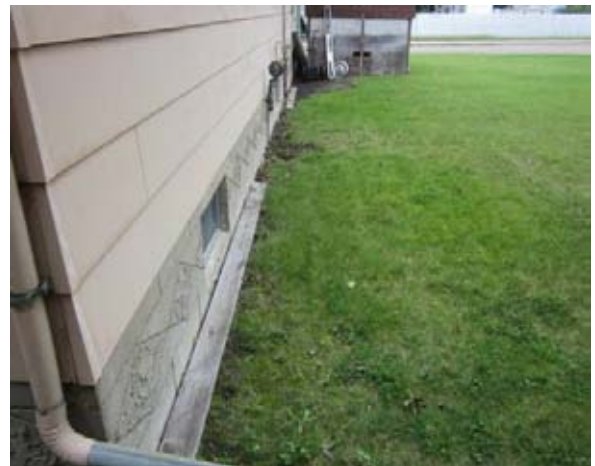
- Slopes to House
 Flower Bed
 Hedge
 Tree
 Ravine
 Earth to Wood
 Site Erosion
 No Swale

Regrade / maintain to slope away from structure to reduce foundation deterioration potential water entry and subsequent damages.

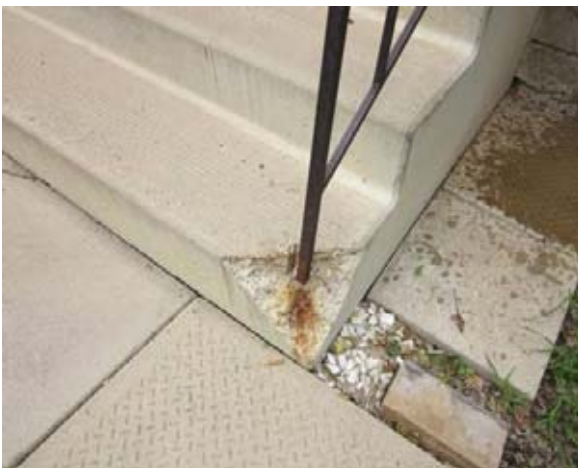
Deck/Patio

Damaged: Yes

Crack

Deterioration

Rot

Repair/replace to reduce further damages.

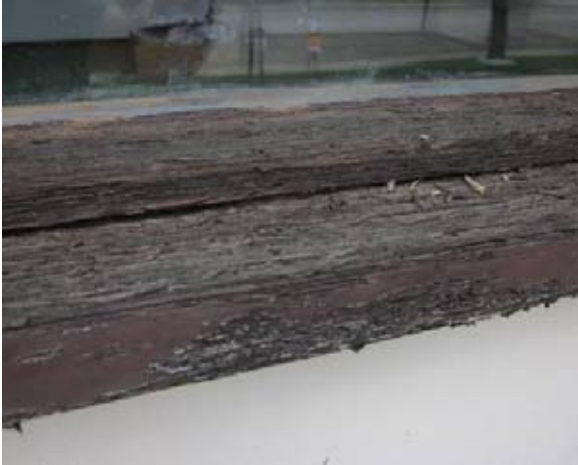
Budget to replace. Windows showing signs relative to age and wear. Maintain wood windows/trim work to reduce deterioration

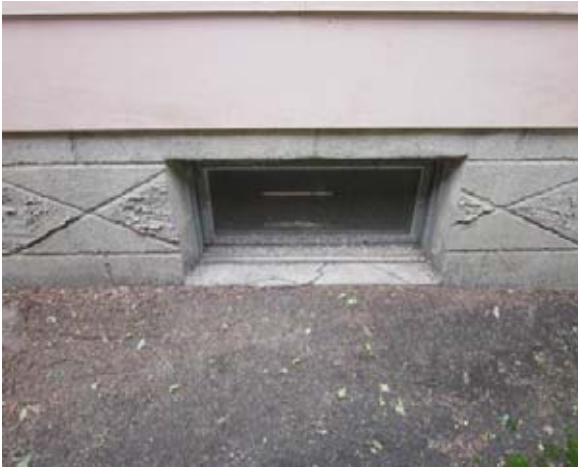
Window Well

Improper Drainage

Recommend installing window well to reduce moisture related damages.

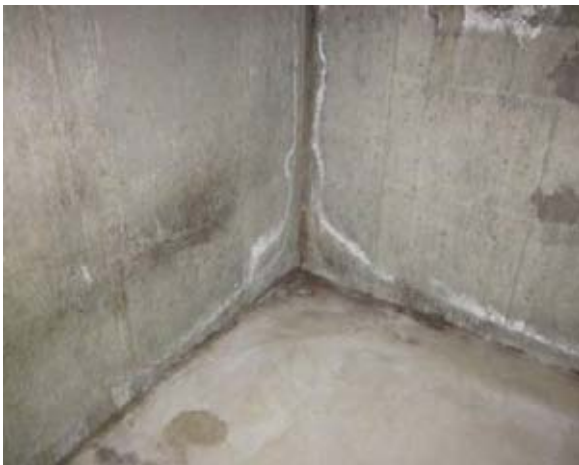
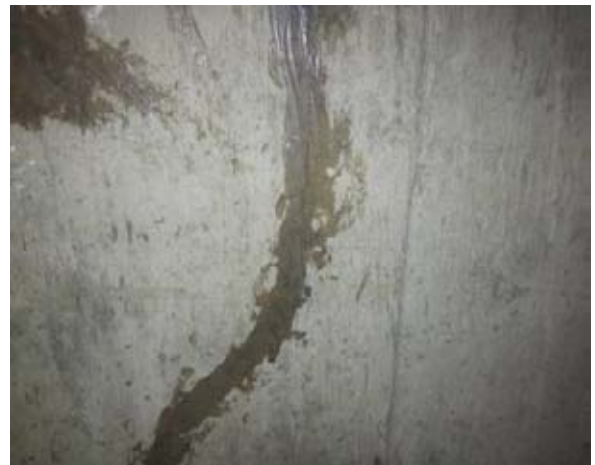
Efflorescences noted. Monitor for further staining. Correct as required. Consult a qualified structural contractor to evaluate moderate cracks and determine methods of repairs

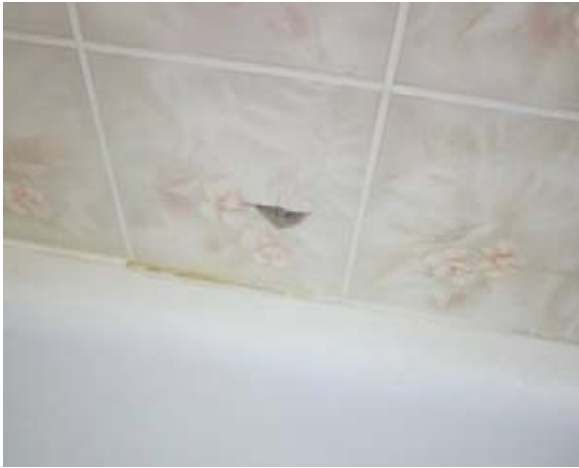
Damaged: Yes

Budget to replace to reduce moisture related damages.

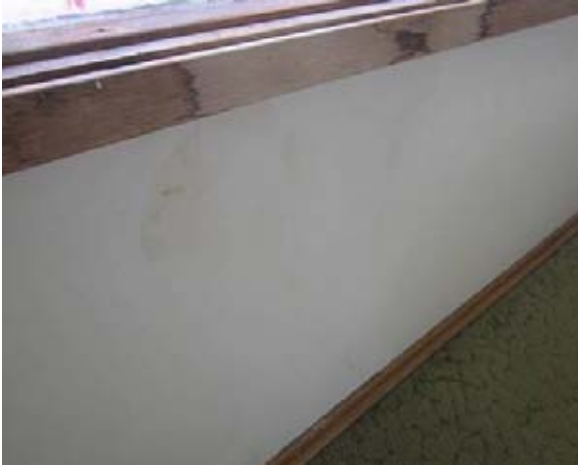
Patched Stain Drywall Brick Wood Wallpaper

Monitor previous patch repairs to ensure repairs remain effective.

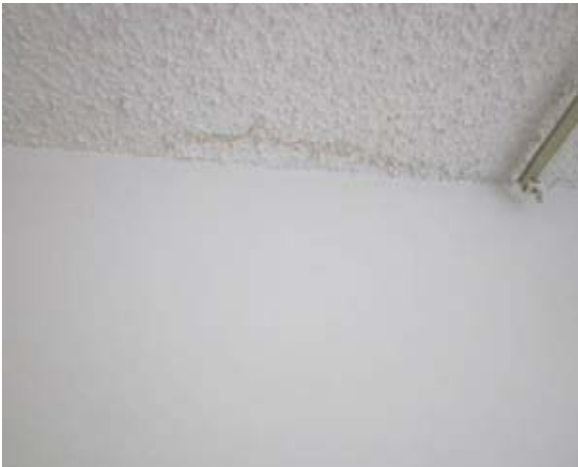
Ceiling

- Patched
 Stain
 Drywall
 Stipple

Monitor previous staining to ensure leak remains inactive
