Visual Property Inspection

30 Pelican Point
Murray Lake, Saskatchewan

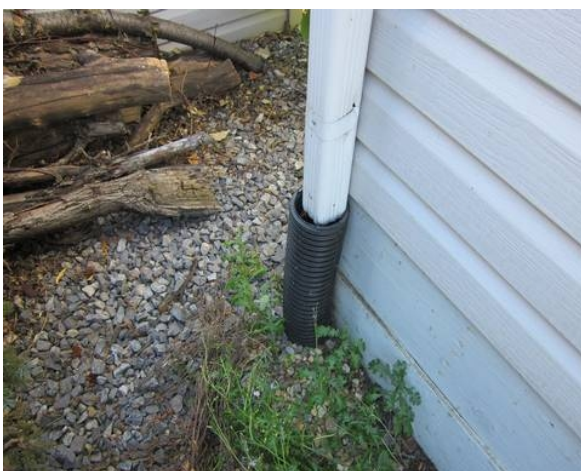
Damaged: Yes

Repair as required, when trees are removed away from structure

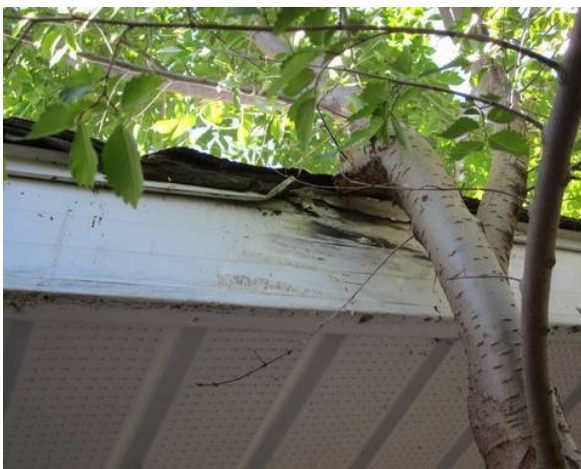
Some damage noted from trees rubbing. Repair replace as required.

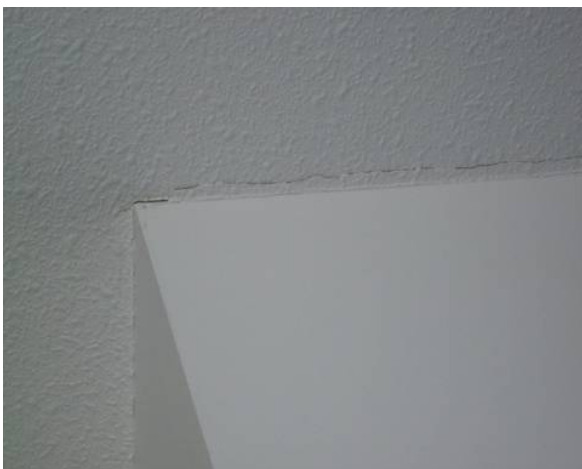
Settlement crack noted. Monitor for further movement.
