Visual Property Inspection

Danyliw Acreage
Glaslyn, Saskatchewan

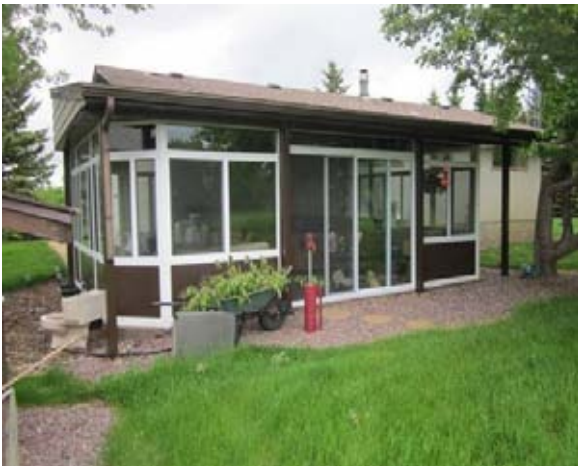
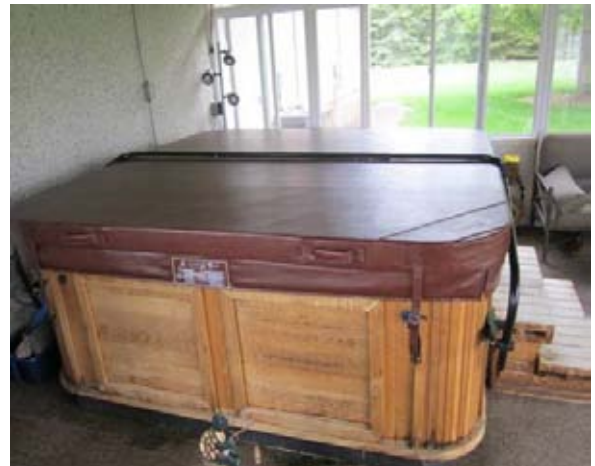
Enclosed solarium noted. Hot tub tested on off only.

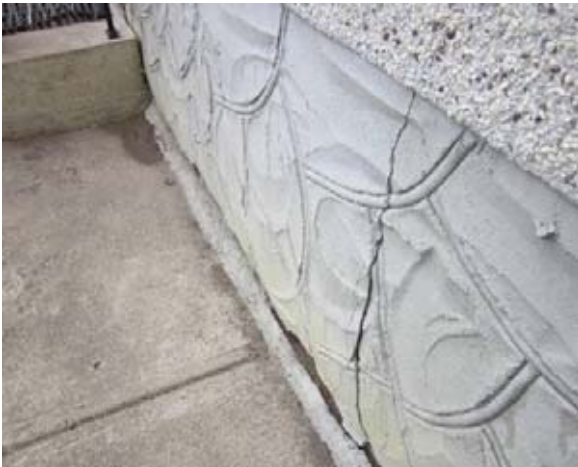
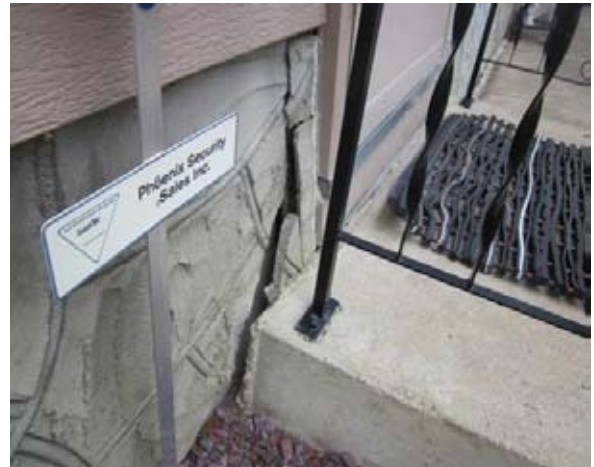
Further inspection required by contractor to determine cause of deflection and extent of damage.

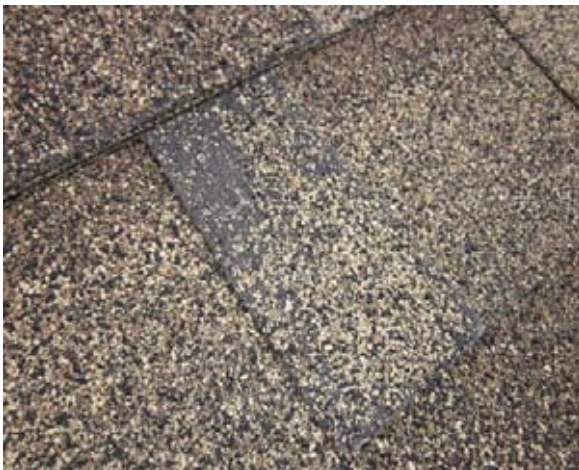
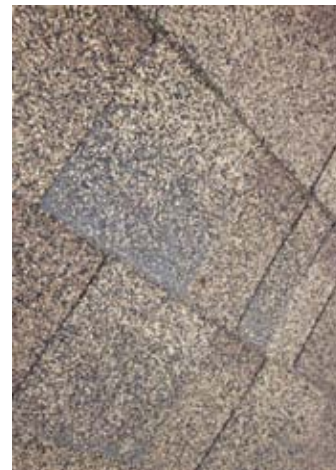
Some un even wear noted.

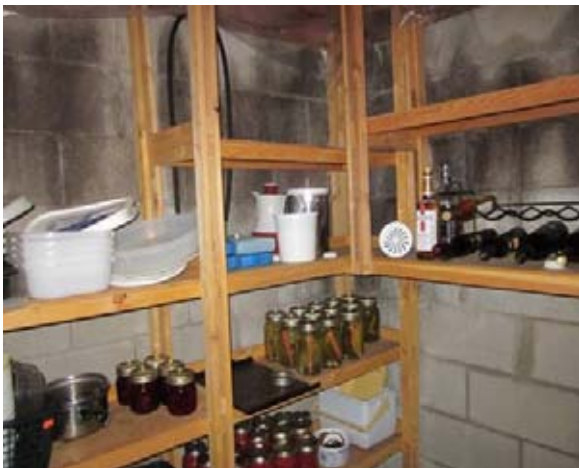
Suspect staining noted, recommend having tested and removed. Recommend installing ventiation for air movement to reduce staining.

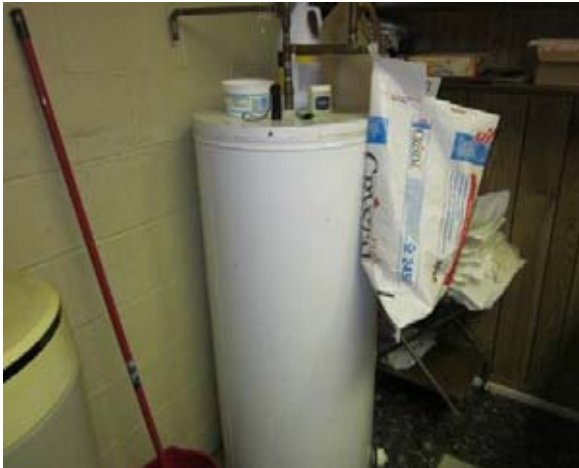
Budget to replace. Water heater has exceeded typical life expectancy.

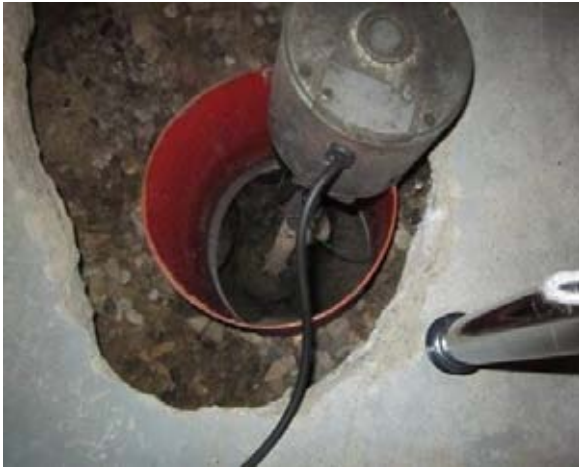
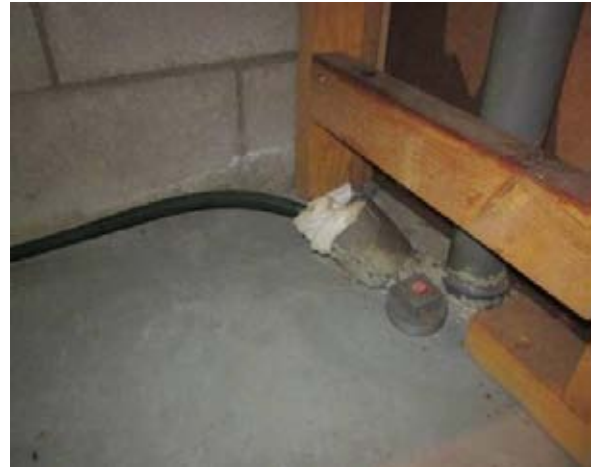
Dry at time of inspection.

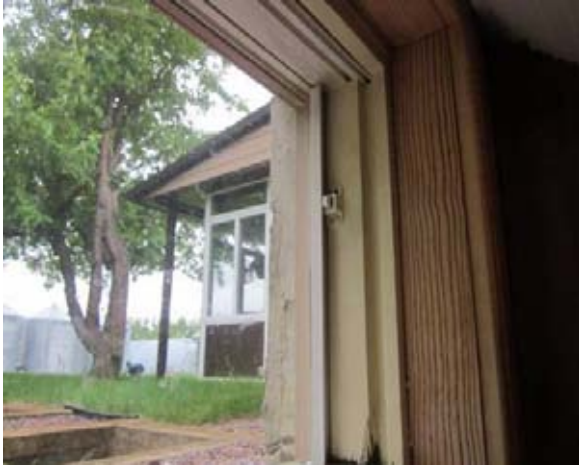
Missing section noted. Replace locking hardware to promote security.

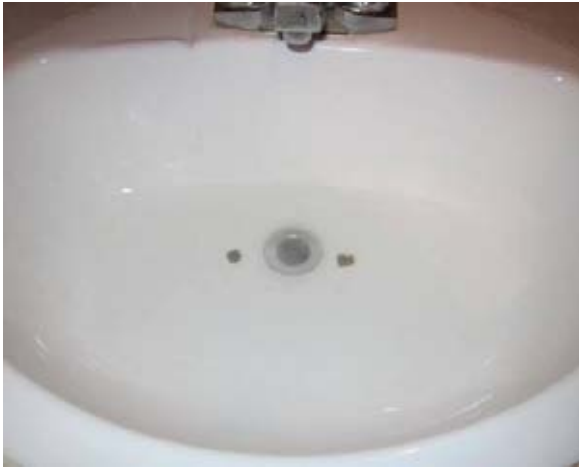
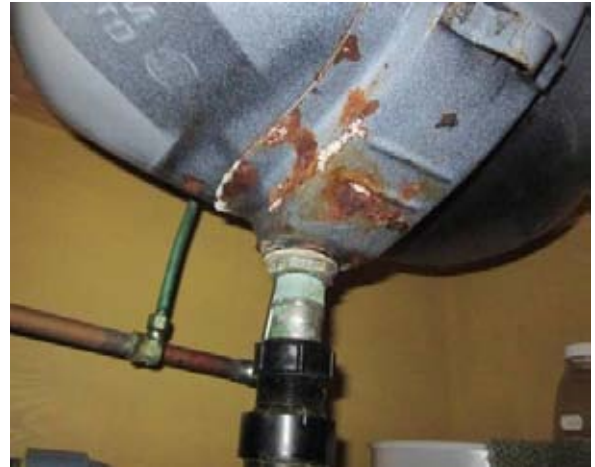
Budget to replace worn sink to reduce secondary water damages
