Visual Property Inspection

**541 100th Str
North Battleford, Saskatchewan**

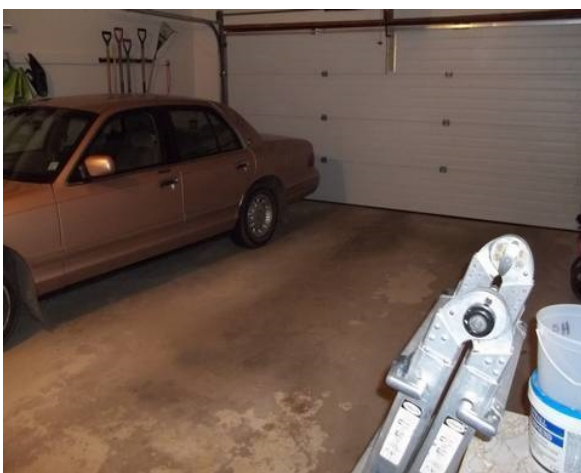
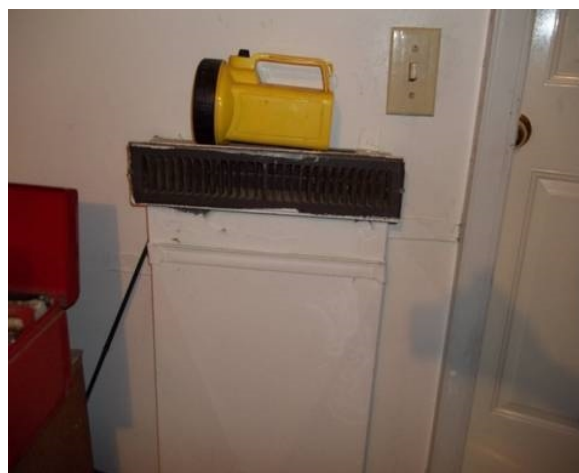
heat vent from interior

Check on code with local authorities regarding venting from interior. Recommend removing to reduce any associated hazards.

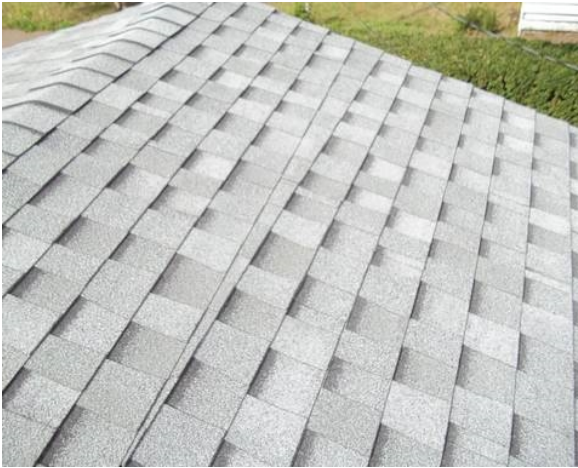
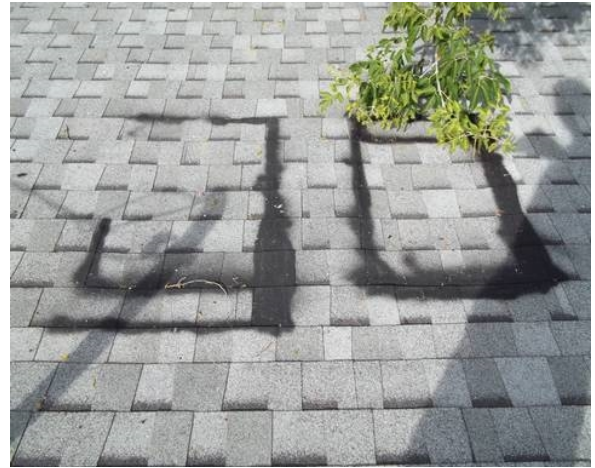
Above sun deck. Appear to have had sunlights removed in past.

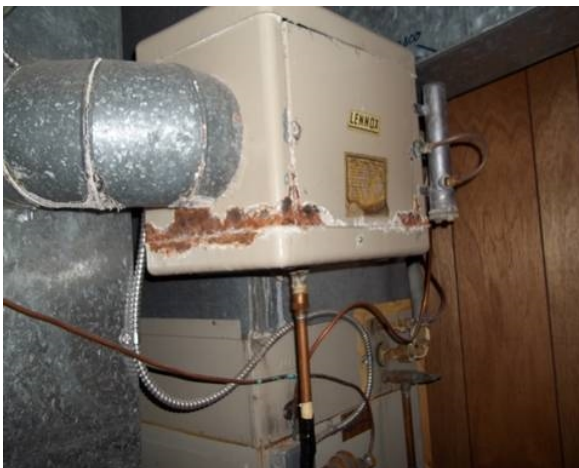
Damaged: Yes

Not in use.

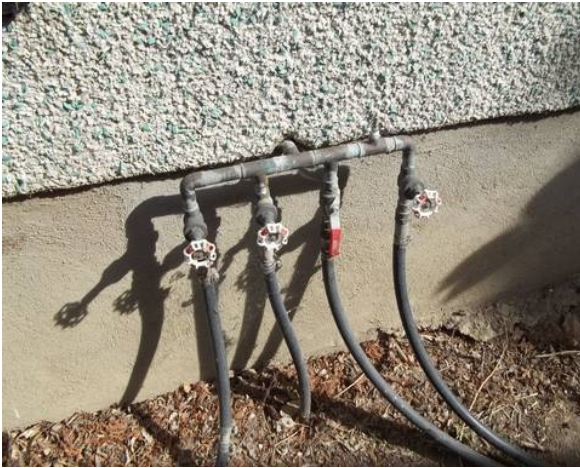
water supply shut off at time of inspection.
