Visual Property Inspection

**3 Bekola Ave Kopps Cove
Turtle Lake, Saskatchewan**

Date: 24-Jun-2013

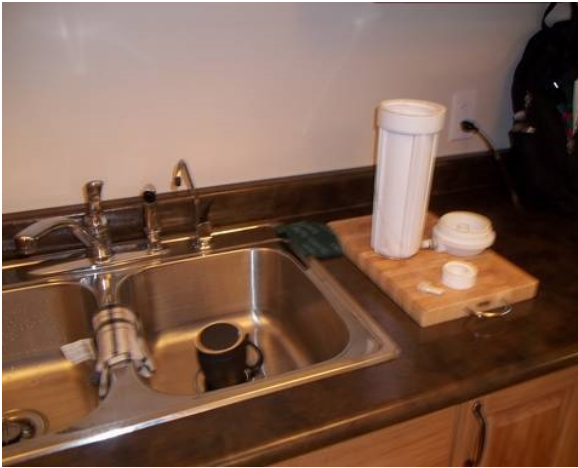
Tested for 5-10 minutes, no leaks at time of inspection Osmosis tap not working at time of inspection. Owner aware and is in the process of having repaired.
