Visual Property Inspection

12 Riverbend Cr
North Battleford, Saskatchewan

Date: 21-Apr-2015

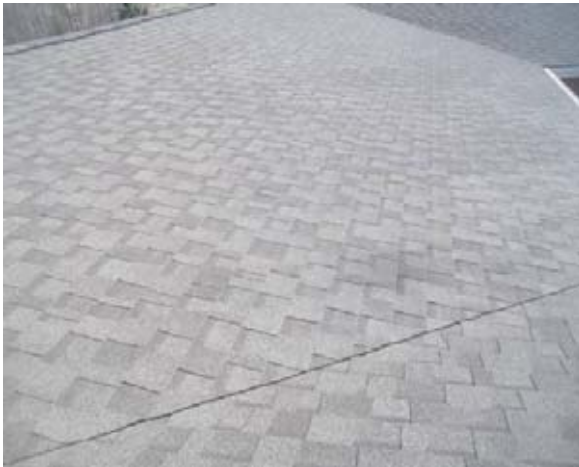
Main Roof

- Flat
 Gable
 Valley
 Hip
 Shed
 Other

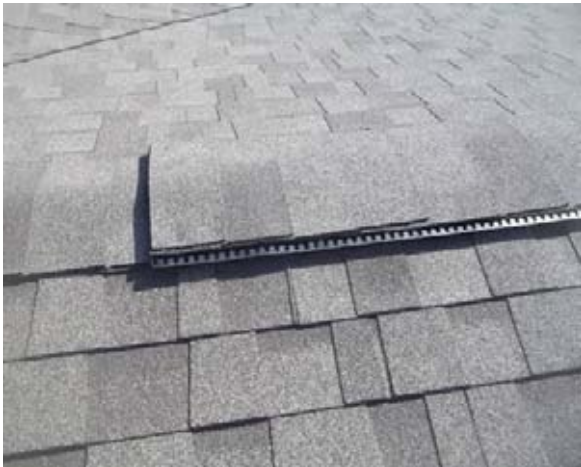
Flashing

- Not Checked
 Chimney
 Dormer
 Drip Edge
 Flat Roof
 Skylight
- Roof to Wall
 Stack
 Valley
 Roll Roofing
 Aluminum
 Copper
- Rubber
 Gap
 Deterioration
 Corrosion
 Tarred
 Reseal
- Improper
 Replace When Re-roofing

Damaged: No

Seal and maintain flashing to reduce water entry related damages. Remove debris to allow proper water flow.

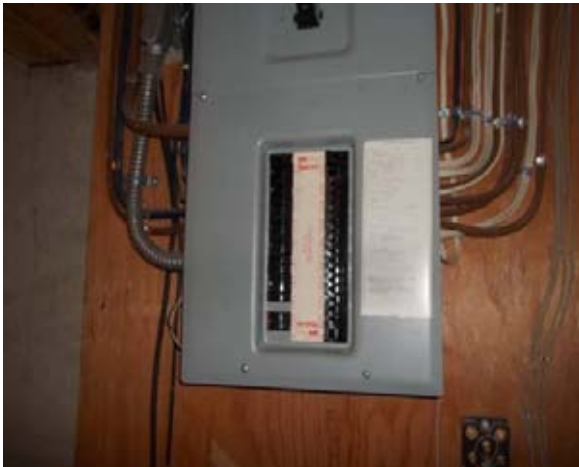
Distribution Panel

- Not Opened Non Standard Installation Obstructed **Damaged: No**
 Obsolete Unsecured Corrosion
Location Storage Rm

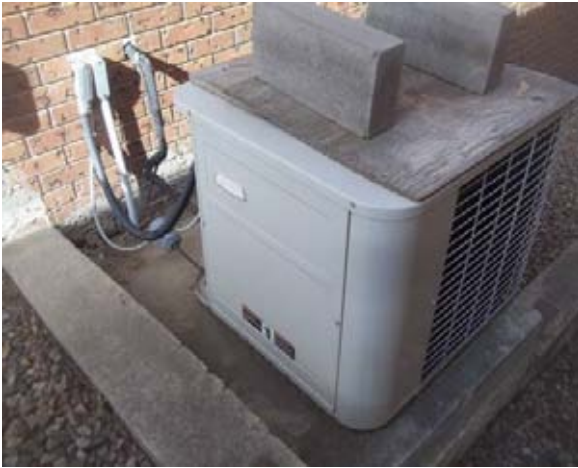
- Not Checked
 Evaporative
 Central
 Geo-Therm
 Air
 Through Wall
 Damged Fins
 Corrosion
 Noisy
 Loose
 Unsecured
 Not Level
 Dirty

Testing A/C unit during low outdoor temperatures will cause system failure. Determine function during cooling season.
