**Visual Property Inspection**

1491 103rd  
North Battleford, SK

**Prepared for :**

Norman Diane Seltzer

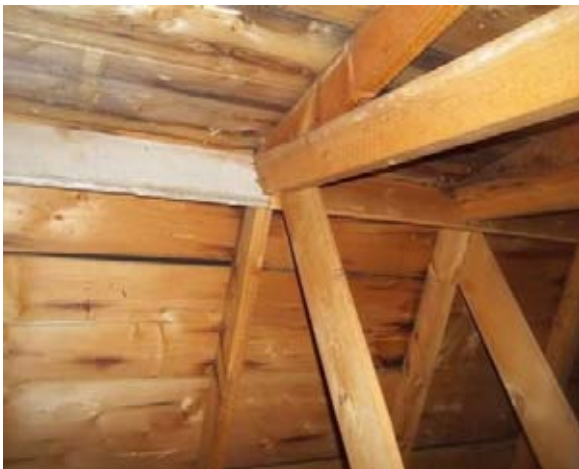
**Structure**

*Vermiculate insulation noted, possible asbestos present. Have tested. Read attached literature.*

*Recommend installing additional roof vents to promote attic ventilation and reduce attic moisture/condensation related damages.*

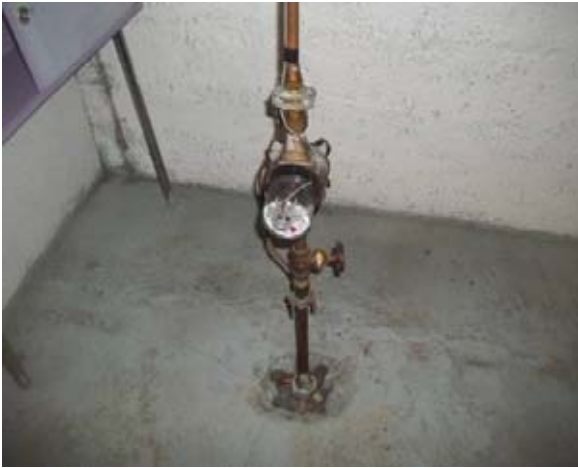
**Public Supply**

*Budget for system replacement. Galvanized plumbing is corrosive by nature. Monitor for decreased water flow indicating initial signs of failure. Contact plumber to repair leak as required to reduce moisture related damages.*

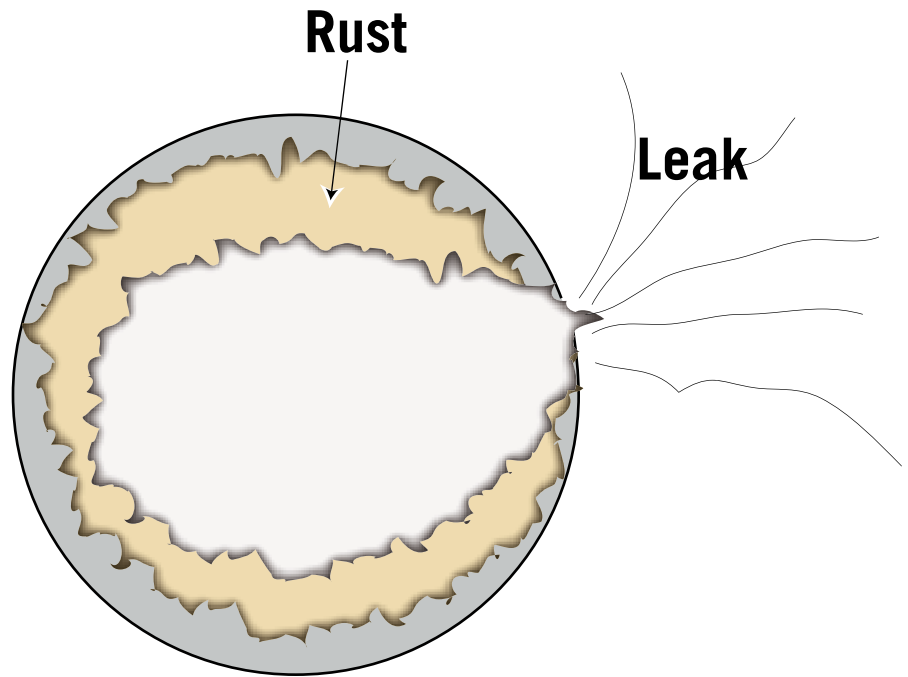
## Recognizing Galvanized Steel Pipe

Galvanized steel pipe has not been used in residential homes since around 1950. Any galvanized steel found in homes today, therefore, will generally be well past its shelf date. If you have galvanized steel pipes, consider replacing them, especially since rust is not the only problem you will face. Other problems include:

- **Poor water flow**
  - galvanized steel pipe rusts from the inside out, diminishing the effective cross-sectional area. Any pipe found today will likely have an interior comprised mostly of rust.
- **Rust in the water** – you may see rust in the water when you first turn on the taps. It will, however, quickly clear as you run the water, but unsightly stains may develop on plumbing fixtures.
- **Leaks** – the pipe eventually rusts right through, usually at the threaded joints where the steel is the thinnest, causing leaks.
- **Home insurance** – many insurance companies will not insure homes with galvanized steel pipe because of the risk of major leaks.

Although galvanized steel does not present a health hazard, you should still consider replacing it since you run the risk of major leaks that may cause serious damage to your house, resulting in expensive repairs. Replacement will also clear up minor problems, such as poor water flow. If you find galvanized steel in your home, contact a plumber to have it replaced. Do not wait for a leak!
