Visual Property Inspection

2143 101 Str
North Battleford, SK

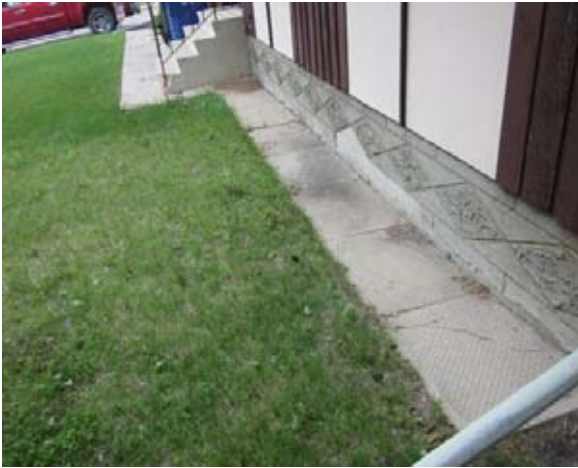
Deck/Patio

Damaged: Yes

Crack

Deterioration

Rot

Repair/replace to reduce further damages.

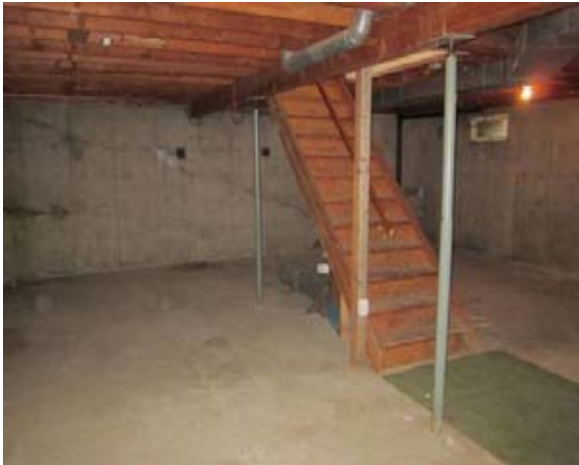
Basement/Structure

Efflorescences noted. Monitor for further staining. Correct as required.

Efflorescences noted. Monitor for further staining. Correct as required. Consult a qualified structural contractor to evaluate moderate cracks and determine methods of repairs
