Visual Property Inspection

Danyliw Acreage
Glaslyn, Saskatchewan

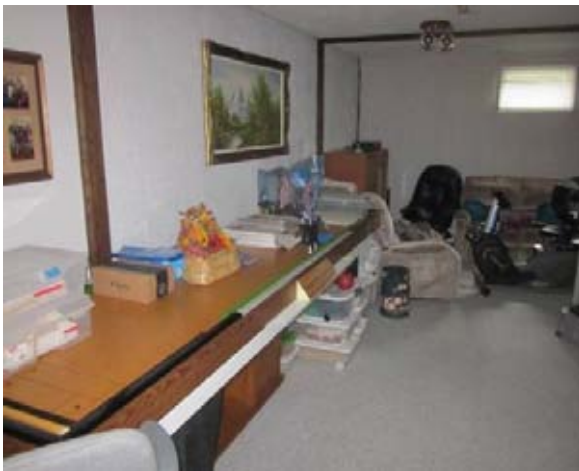
Suspect staining noted, recommend having tested and removed. Recommend installing ventiation for air movement to reduce staining.
