Visual Property Inspection

**541 100th Str
North Battleford, Saskatchewan**

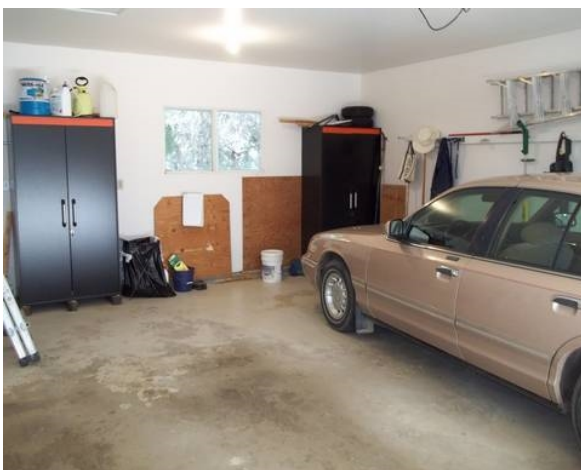
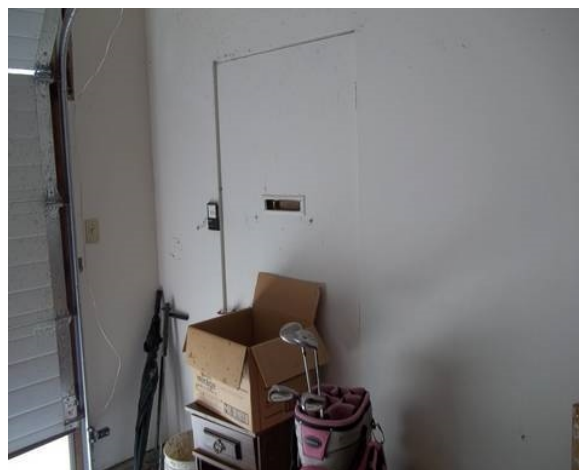
heat vent from interior

Check on code with local authorities regarding venting from interior. Recommend removing to reduce any associated hazards.
