Visual Property Inspection

**3 Bekola Ave Kopps Cove
Turtle Lake, Saskatchewan**

Date: 24-Jun-2013

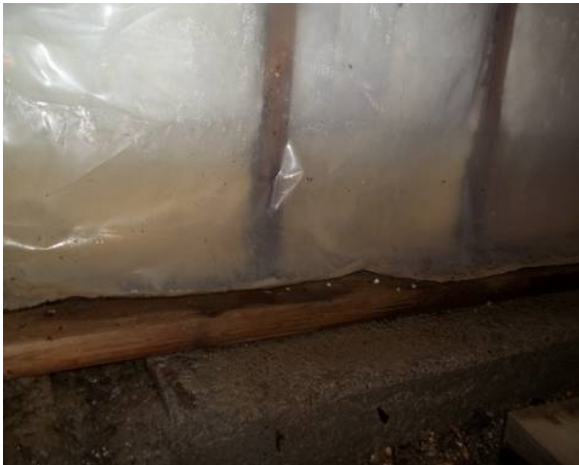
Insulation shows sign of being wet. Recommend contacting a expert to further evaluate the insulation and repair/replace as required to reduce further moisture related damages.
